PHENIX WEEKLY PLANNING

Nov. 21, 2013
Don Lynch

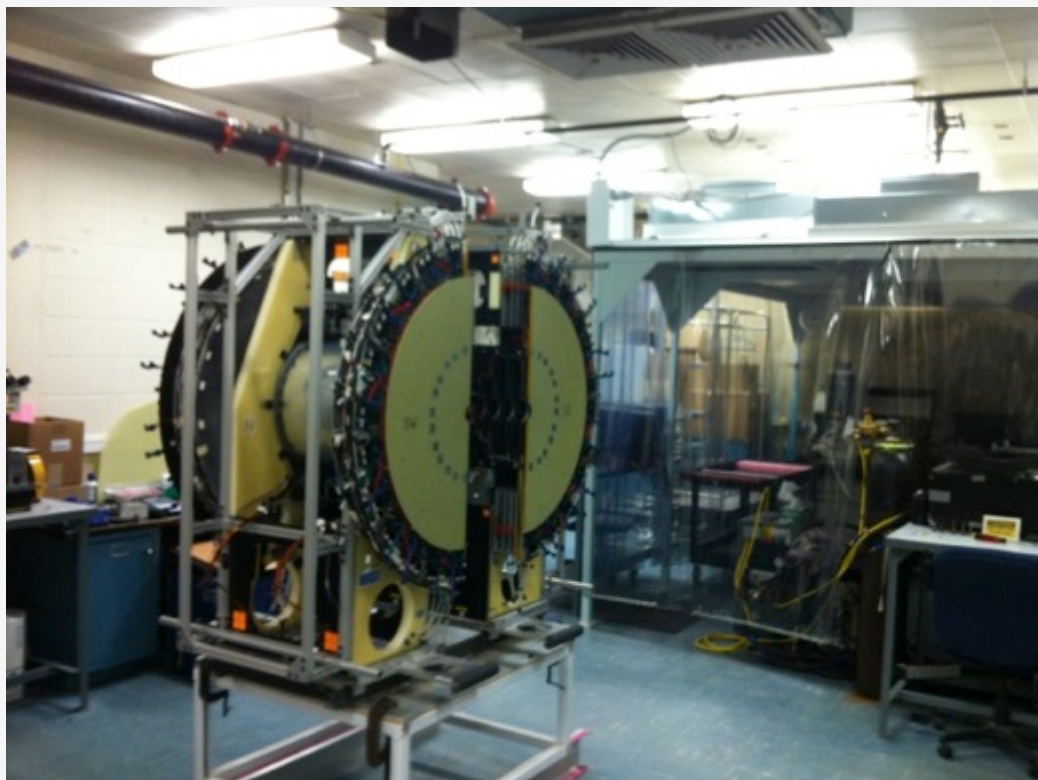
FVTX/VTX East & West Assembled survey at Chemistry completed West moved to IR ready for installation

East ready for transport and installation.

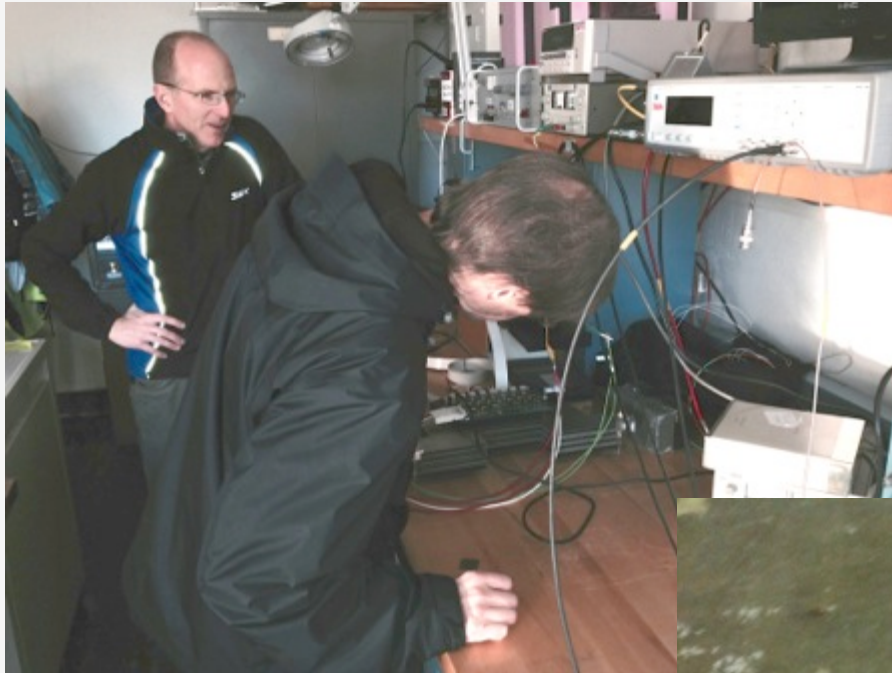
MPC-Ex Initial (Partial) Installation

Vacuum bellows anti-squirm in MPC S Cavity installed.

Installation lifting bracket tested OK

Magnetic survey indicates some ferromagnetic material (NiFe 5%)

Analysis in progress to assess magnetic induced forces etc.

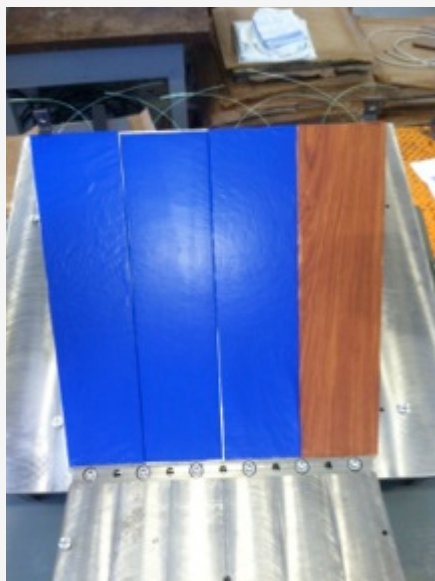
Hcal assembly in progress

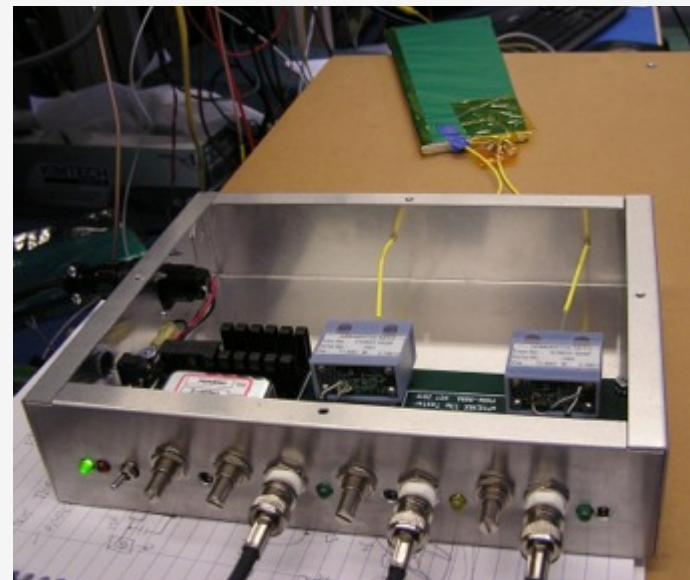
sPHENIX prototype
electronics rack

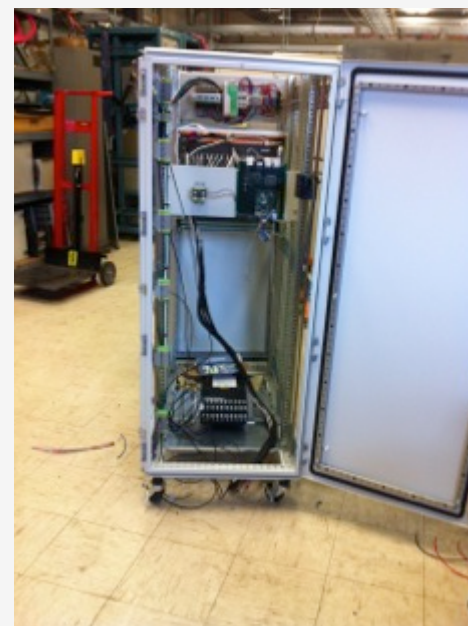
Steve Boose's Tile tester

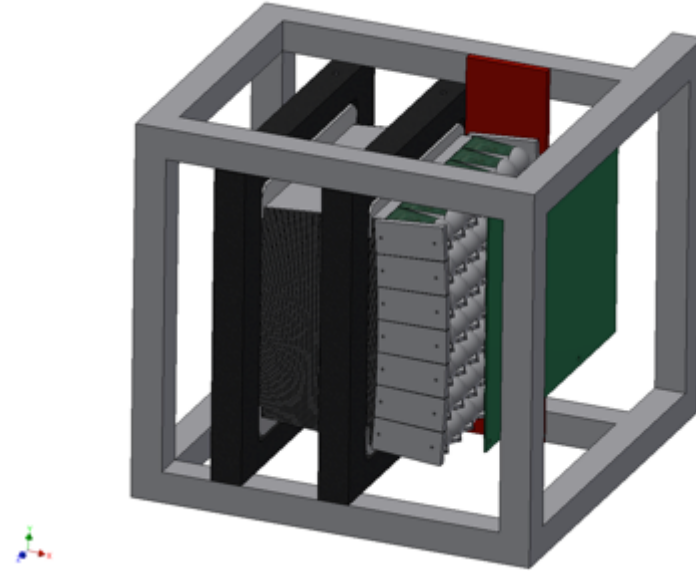
"Droid Army" light collection

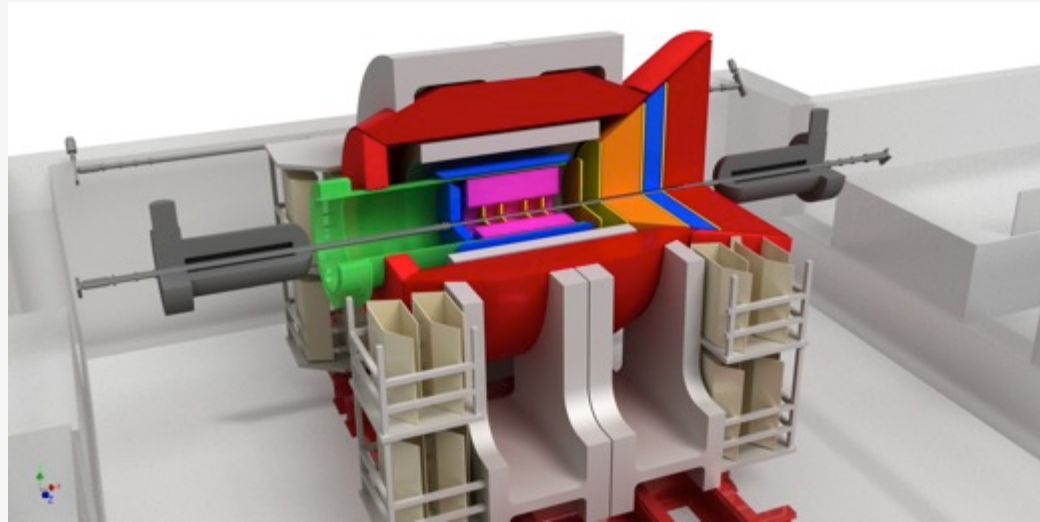
Plan View

ePHENIX

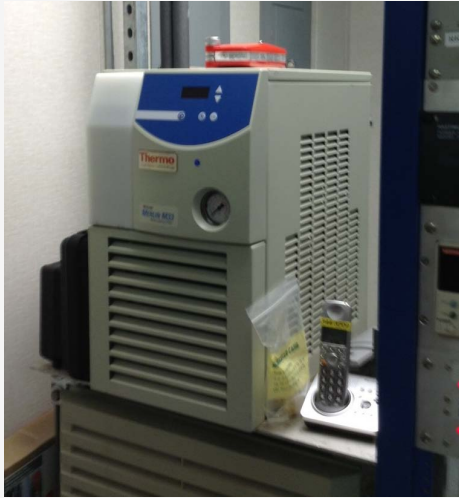
Merlin Chiller

➤Chiller supplied about ½ the flow as in the past.

- Pressure on chiller says ~70-80psi
- Install gauge on supply line and measure actual output pressure.
- Replace chiller with spare if needed.
- Send old chiller out for maintenance or replace.

New Chiller warranty replacement ready for test and installation

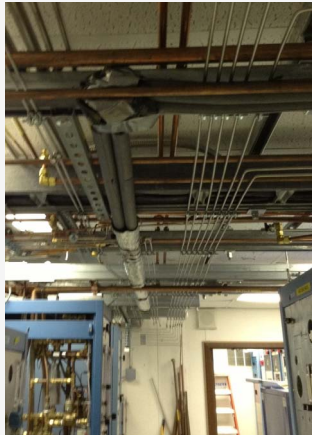
Re-Insulate Glycol lines

❖Remove old polyethylene insulation and wrap and replace with foam rubber insulation.

- Temp of fluid is affected too much by temp change in the gas house.
- Lines are condensing and dripping because of gaps in insulation.

Low priority complete prior to run 14

DONE

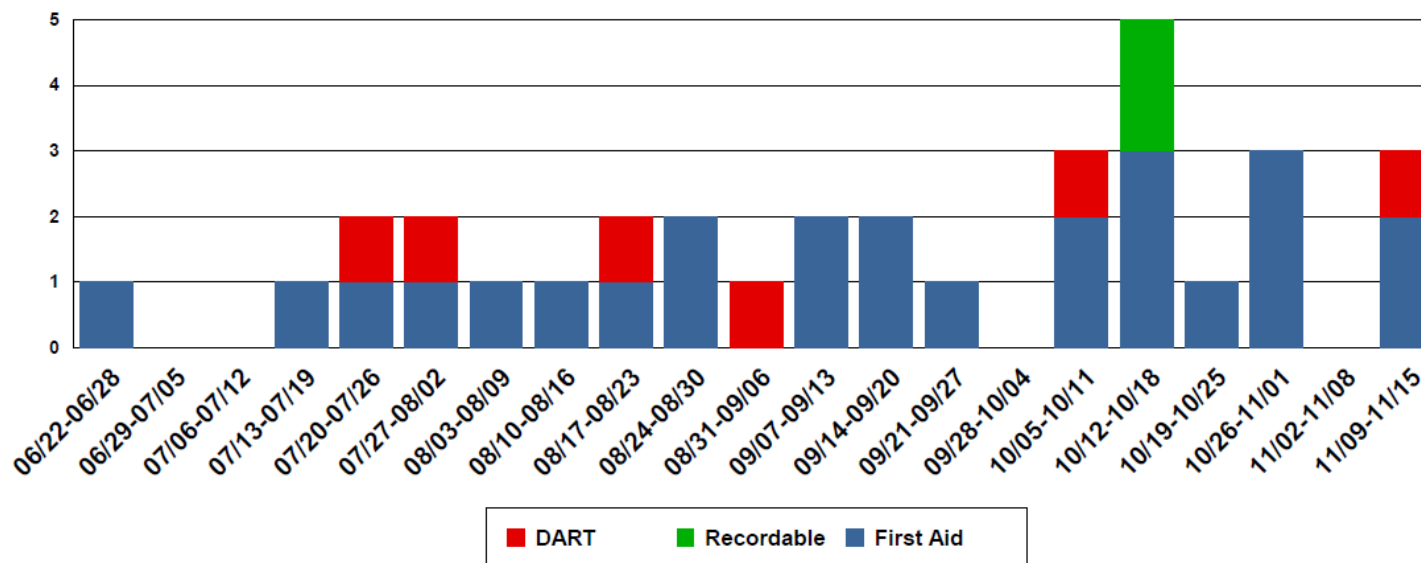
Injuries Per Week
As of 11/15/2013

Injury Status:

FY14 YTD: DART – 2, TRC – 4, First Aid – 11
